Manhole Inspection Summary

Manhole # S59M__008MH

Location Address: **4401 O'DONNELL ST**

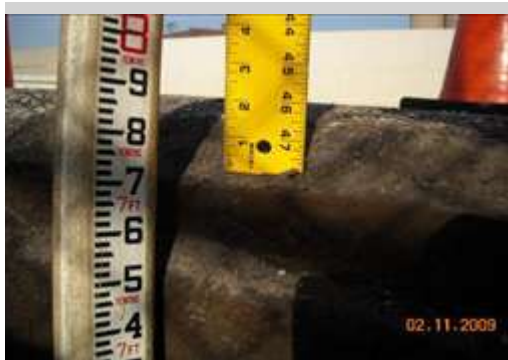
Defect 4

Cover Shape: **Circular** Diameter: **30** (in.) Length: **0** (in.) Dist A/B Grade: **-2** (in.)

FRAME BELOW GRADE

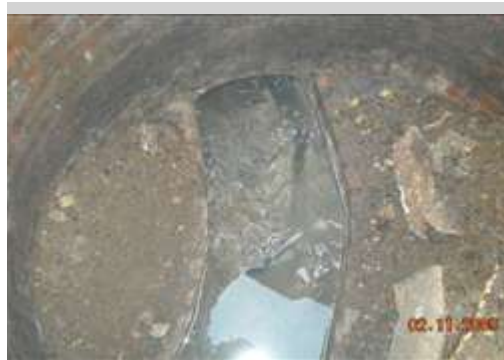
Defect 3

Condition: ☐ Sound ☐ Cracked ☐ Root Intrusion ☐ Deteriorated ☐ Leaks ☒ **Debris**

DEBRIS IN CHANNEL

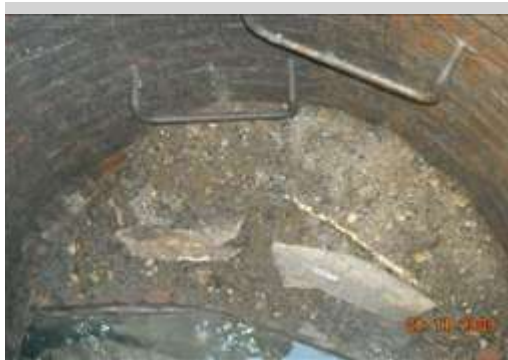
Defect 2

Condition: ☐ Sound ☐ Cracked ☐ Root Intrusion ☐ Deteriorated ☐ Leaks ☒ **Debris**

DEBRIS ON BENCH

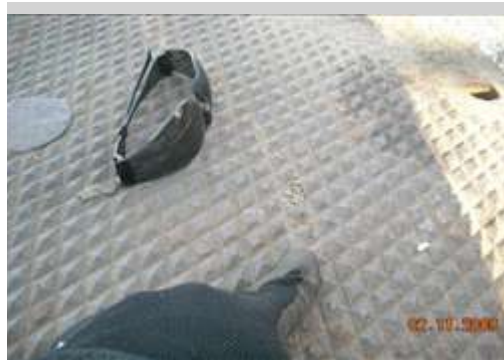
Defect 1

Condition: **Cracked**

CRACKED COVER

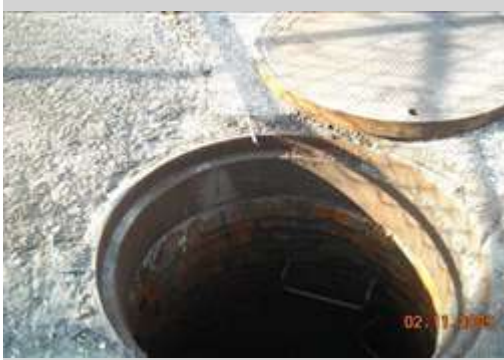
Defect 5

Subject To Ponding: **Sheeting**

INFLOW EVIDENCE FROM SHEETING

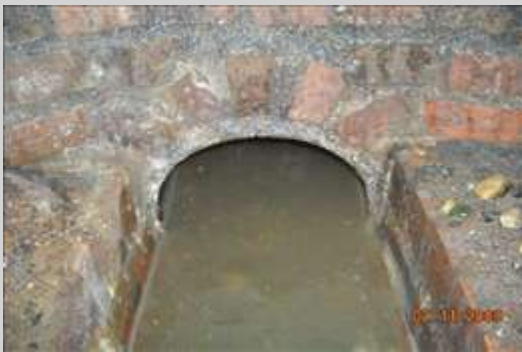
12 O'Clock Outflow

Pipe Height: **12** (in.) Rod and Bar (Angled)
Pipe Material: **Clay** ☐ Pipe Lined
Invert Depth: **8.40** (ft.) Flow Characteristics: **Slow**
Deposits: ☐ None ☐ Mud ☒ **Sludge** ☐ Debris ☐ Grease
Silt Depth: **2** (in.) Deposits Extent: **Light**
Infiltration: **None** Pipe Seal Cond: **Sound**

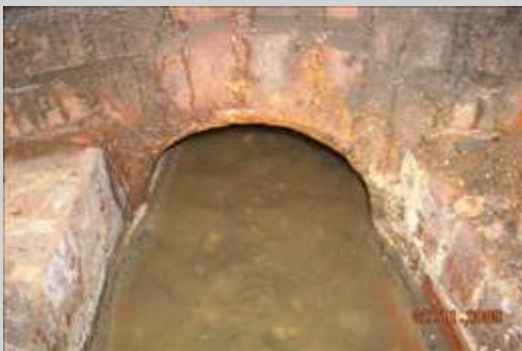
8 O'Clock Inflow

Pipe Height: **12** (in.) Rod and Bar (Angled)
Pipe Material: **Clay** ☐ Pipe Lined
Invert Depth: **8.08** (ft.) Flow Characteristics: **Slow**
Deposits: ☐ None ☐ Mud ☒ **Sludge** ☐ Debris ☐ Grease
Silt Depth: **2** (in.) Deposits Extent: **Light**
Infiltration: **Weeper** Pipe Seal Cond: **Sound**
